Service Bulletin

Subject: Mag Timing Housing- Dowel Pin

Date: 02/23/2017

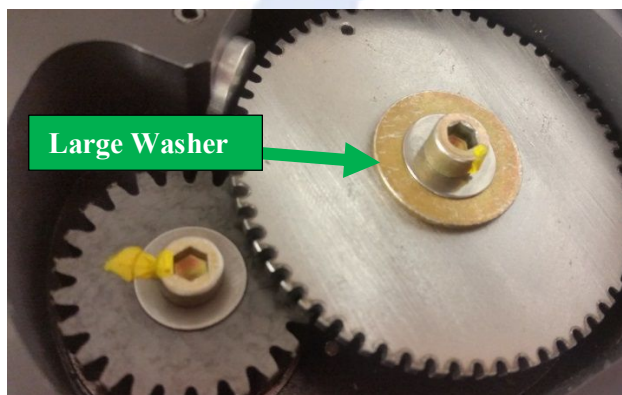
Figure 1: Modified MTH

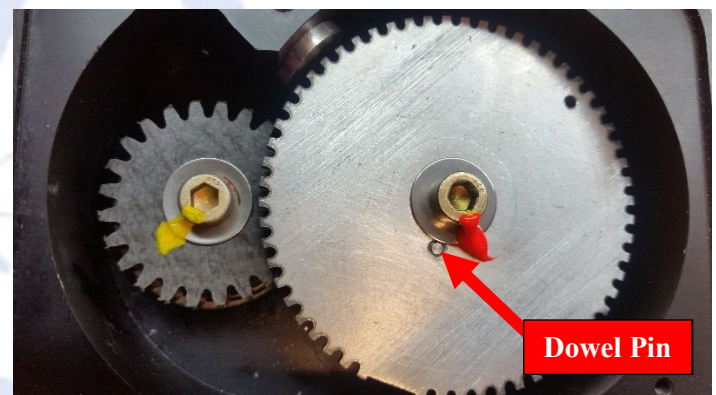
Electroair has received reports of the 6-cylinder Mag Timing Housing (MTH) malfunctioning. The malfunction may cause the trigger wheel within the MTH to become loose due to a dowel pin withdrawing from its designed position. If this happens, the electronic ignition system may not function correctly. The engine timing from the electronic ignition system may slip, and the engine may run rougher than normal. A pilot may notice either a rough running engine, or may notice slightly elevated or slightly decrease cylinder head temperatures.

Figure 2: MTH without Modification

If your unit (Figure 2) contains only a small washer, and you can see the dowel pin, then your unit should be returned to Electroair for service and modification.

What Electroair will do: Affected serial number Mag Timing Housing (MTH) unit owners should contact Electroair and schedule the modification. Units that have NOT been modified with the larger washer may be returned to Electroair for modification/alteration to be configured into the latest design. There will be no charge for this modification.
